Thorens TD-125 MkII Turntable Controller Board Rebuild by Mark Handley November, 2021

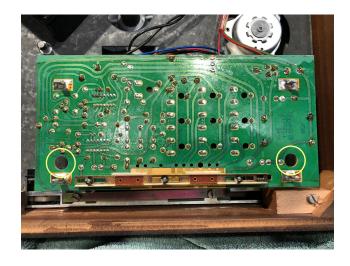
I removed the dust cover, arm, platter and base cover and removed the motor controller board. The large holes lead to slotted capture screws to remove the board.

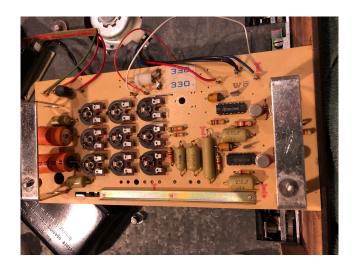
Once the board is free, a soldering gun or pencil can be used to remove the wires to the transformer, speed trim control and motor – I made a wiring diagram first. I also unsoldered the bracket on the right side to access the transistors and resistors underneath. De-soldering braid was used for this step.

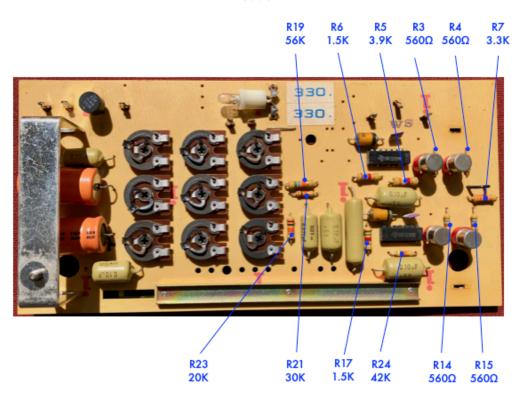
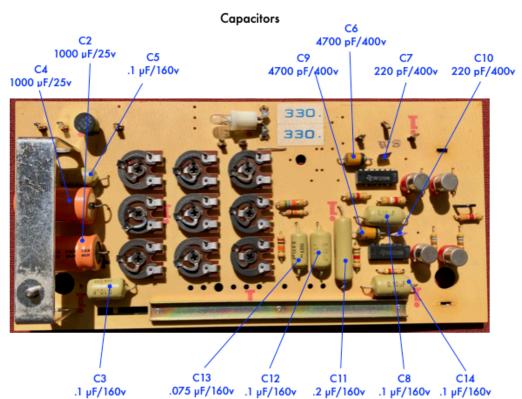
Resistors

I created a diagram of where the resistors and capacitors are located.

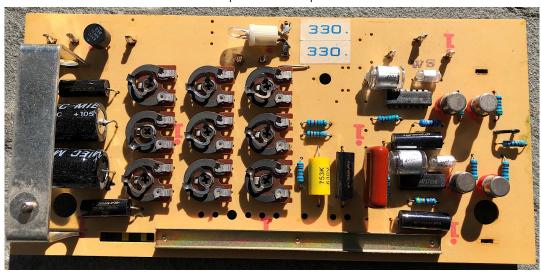
Board with new passive components installed

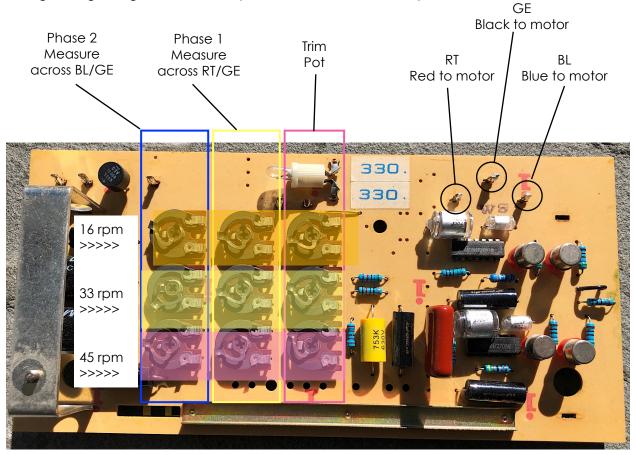
Calibration

To finish up, I wanted to check the output voltage to the motor. It's difficult to make adjustments when the board is mounted in the turntable base and, since I had the board out anyway, I extended the wiring to the transformer, motor and strobe to the bench then made the adjustments there. I found that moving the potentiometers a fraction of a degree resulted in wild voltage swings so I got close to the specifications but not exactly on them.
